WATERCOURSE RESTORATION EFFORTS at the INTERMITTENT CERKNICA LAKE in SLOVENIA

LIFE06 NAT/SLO/000069 – Intermittent Cerknica Lake

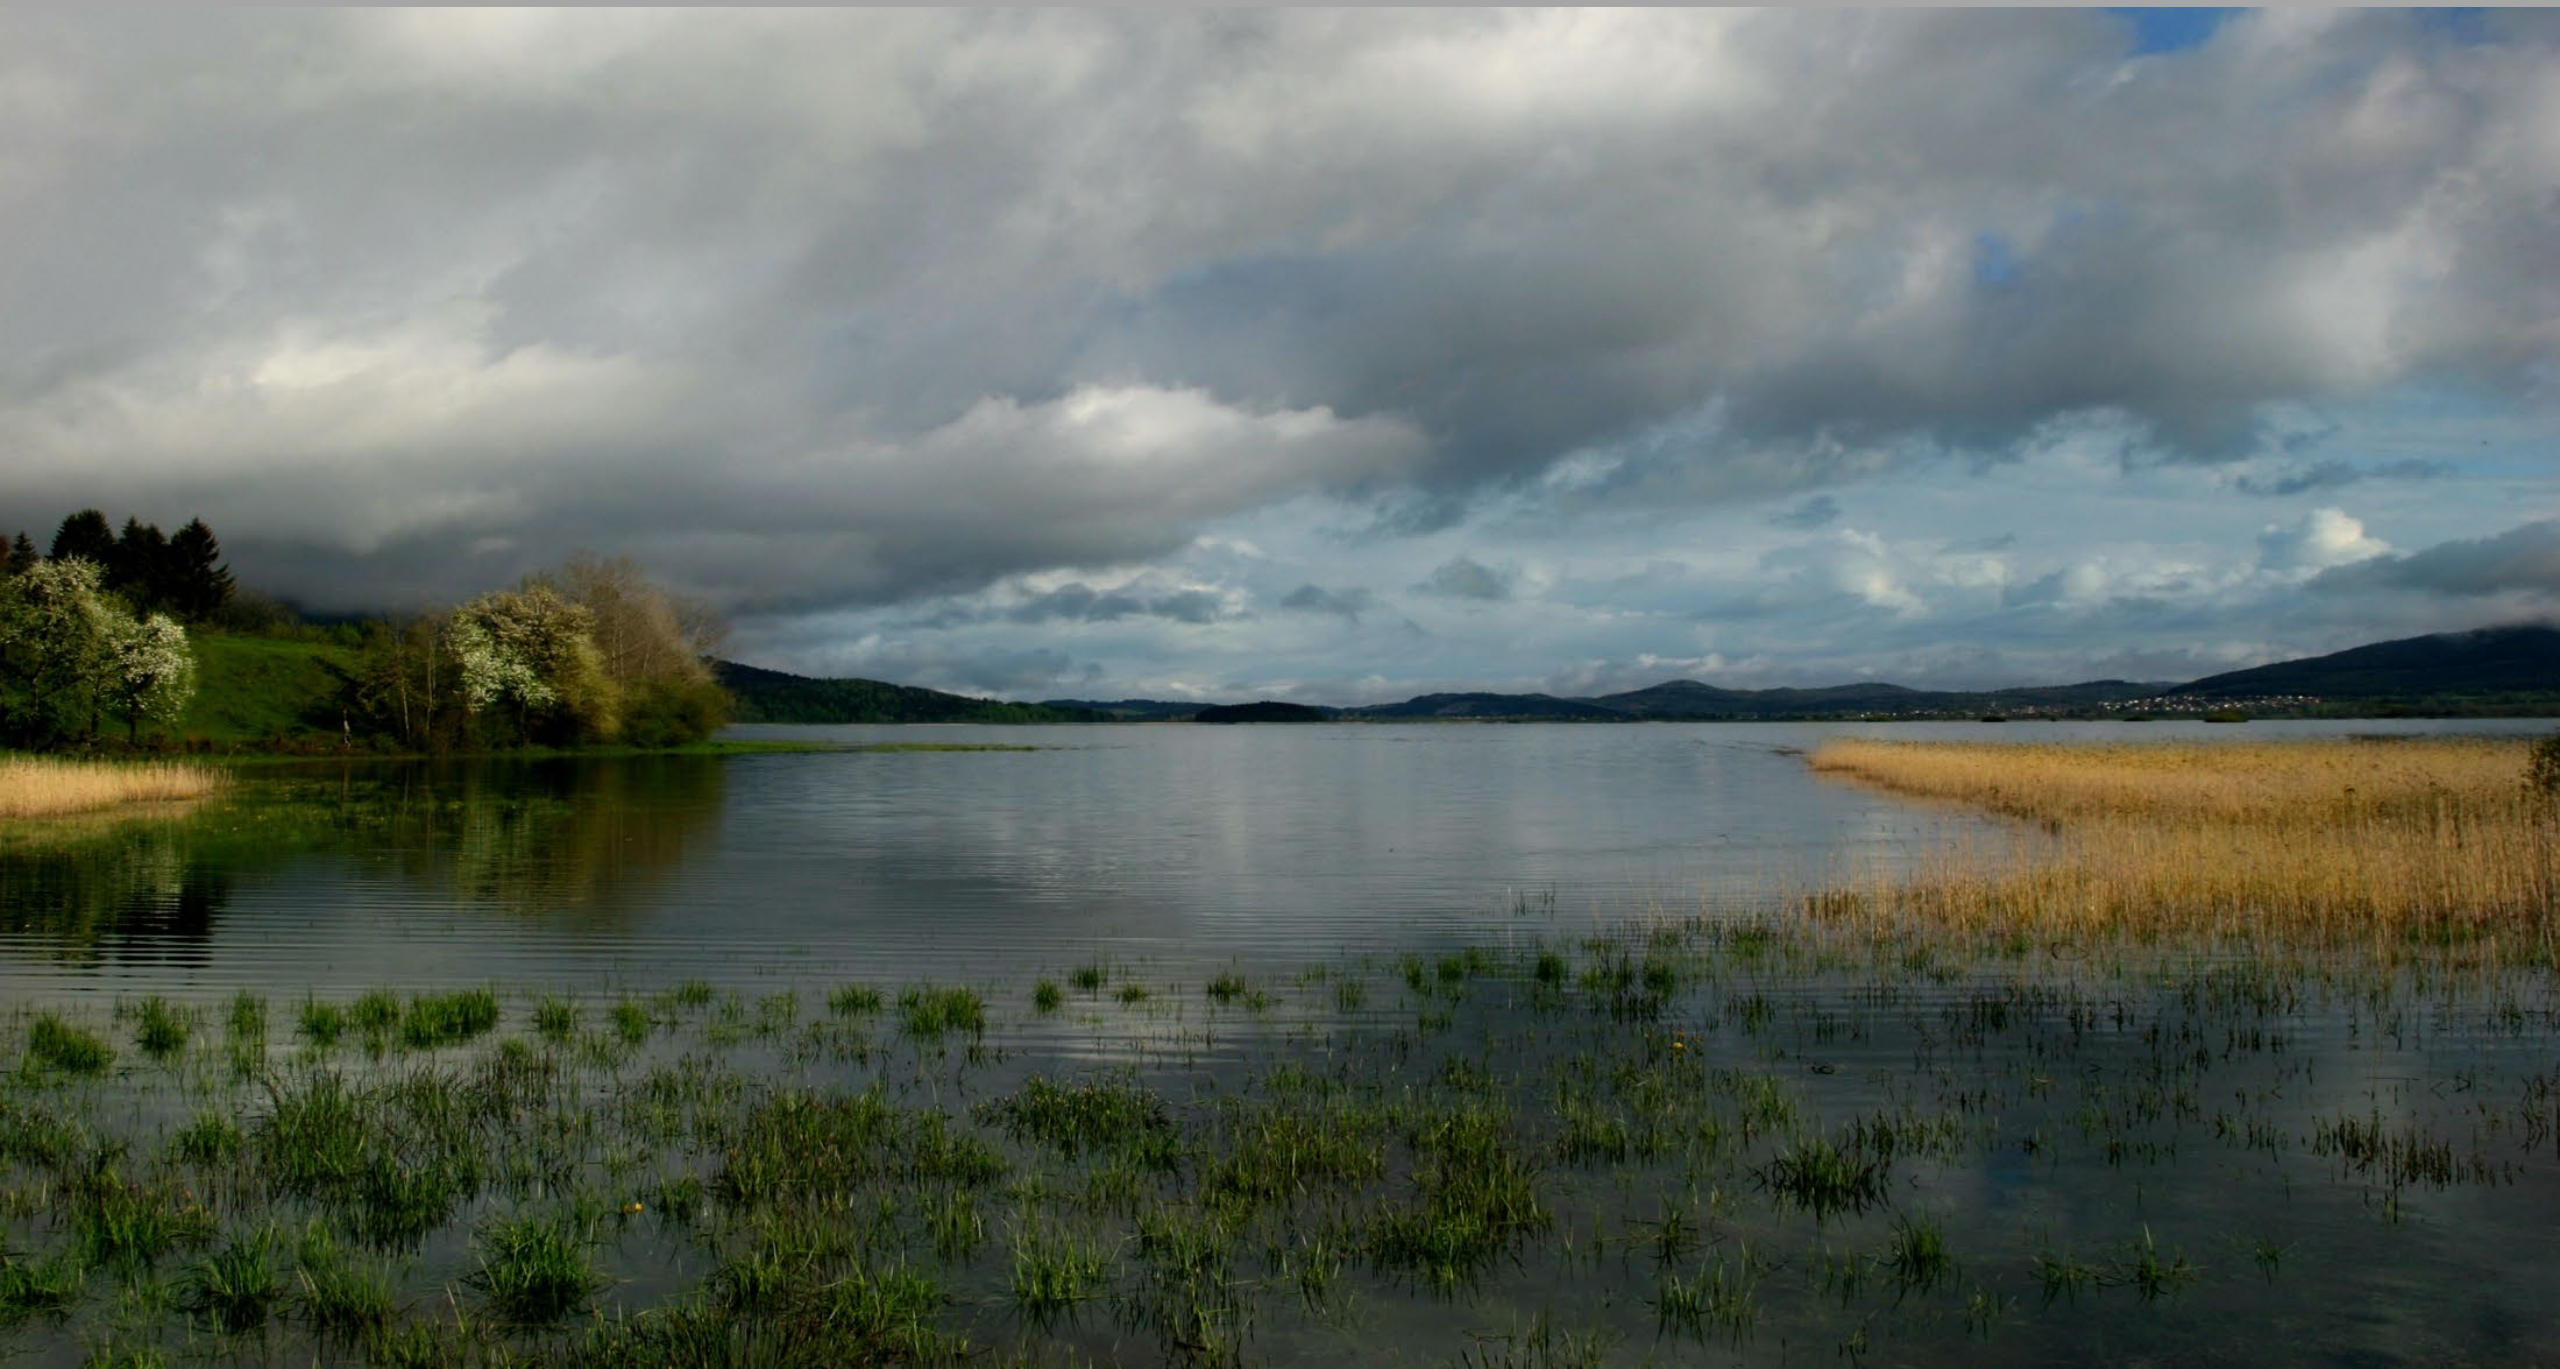
One of many sinkholes at the lake

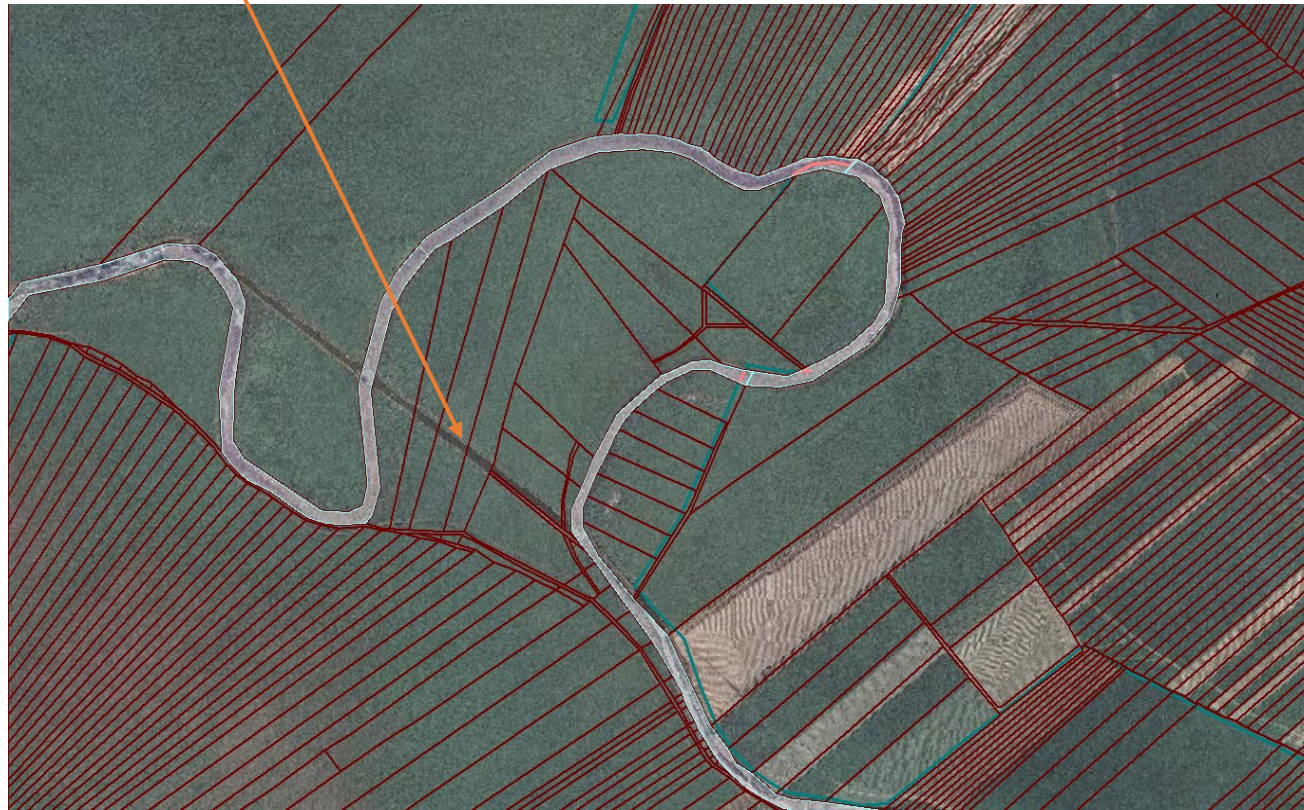
Total length of watercourses on the lake before the implemented regulations was 45 km and after the implementation of regulations, it was 33 km (12 km = 27,6 % reduction in length).

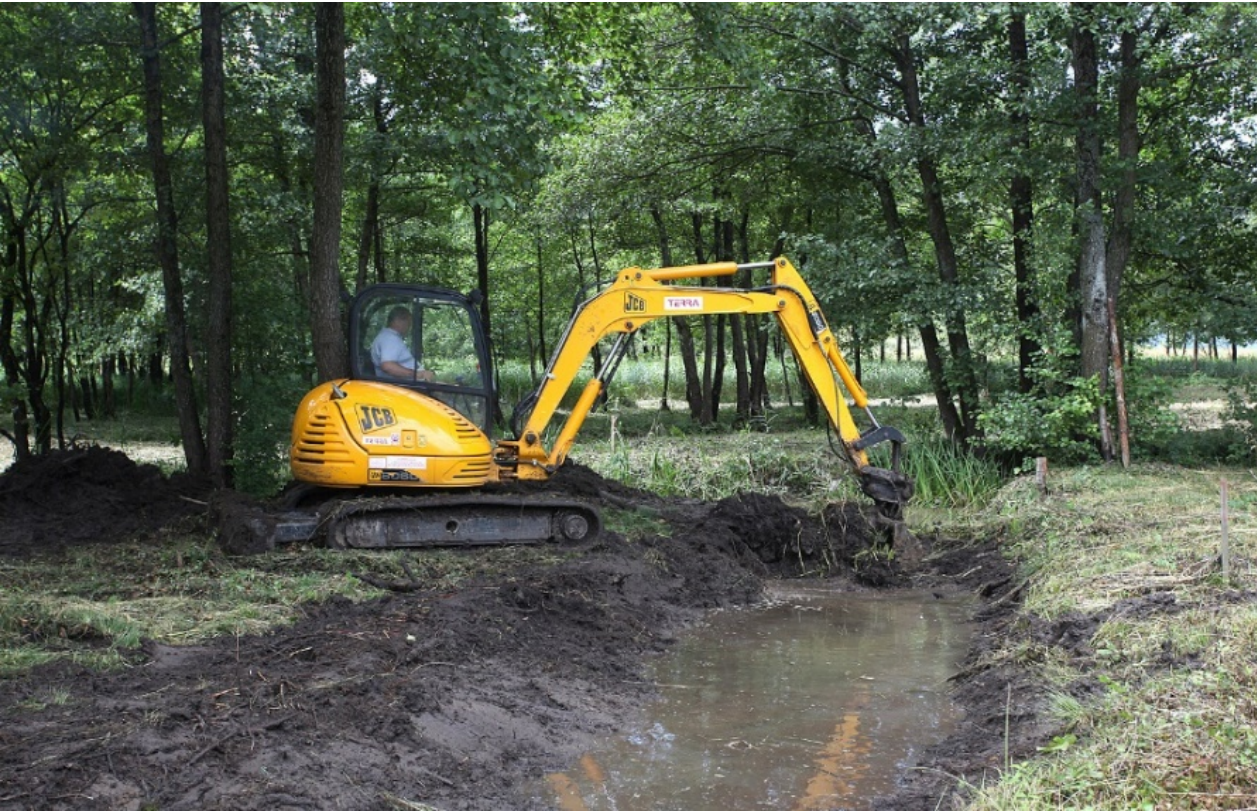
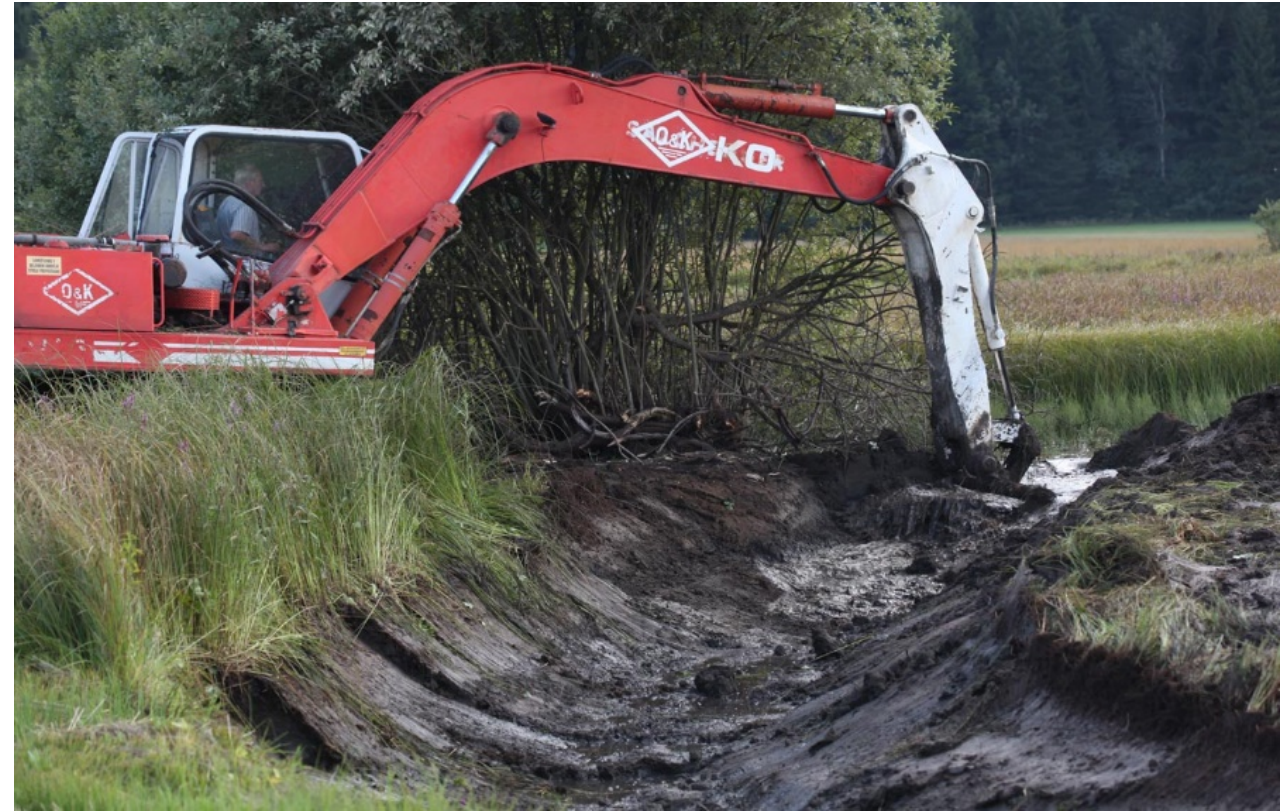
Goriški Brežiček
in 2010 - a year
after finished
works

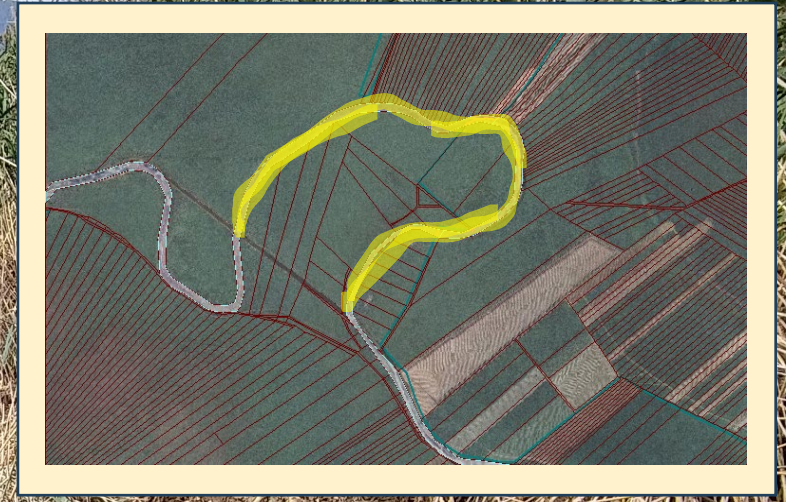
START OF WORK:
In September 2017 drainage ditch
was dug out all over around big meander

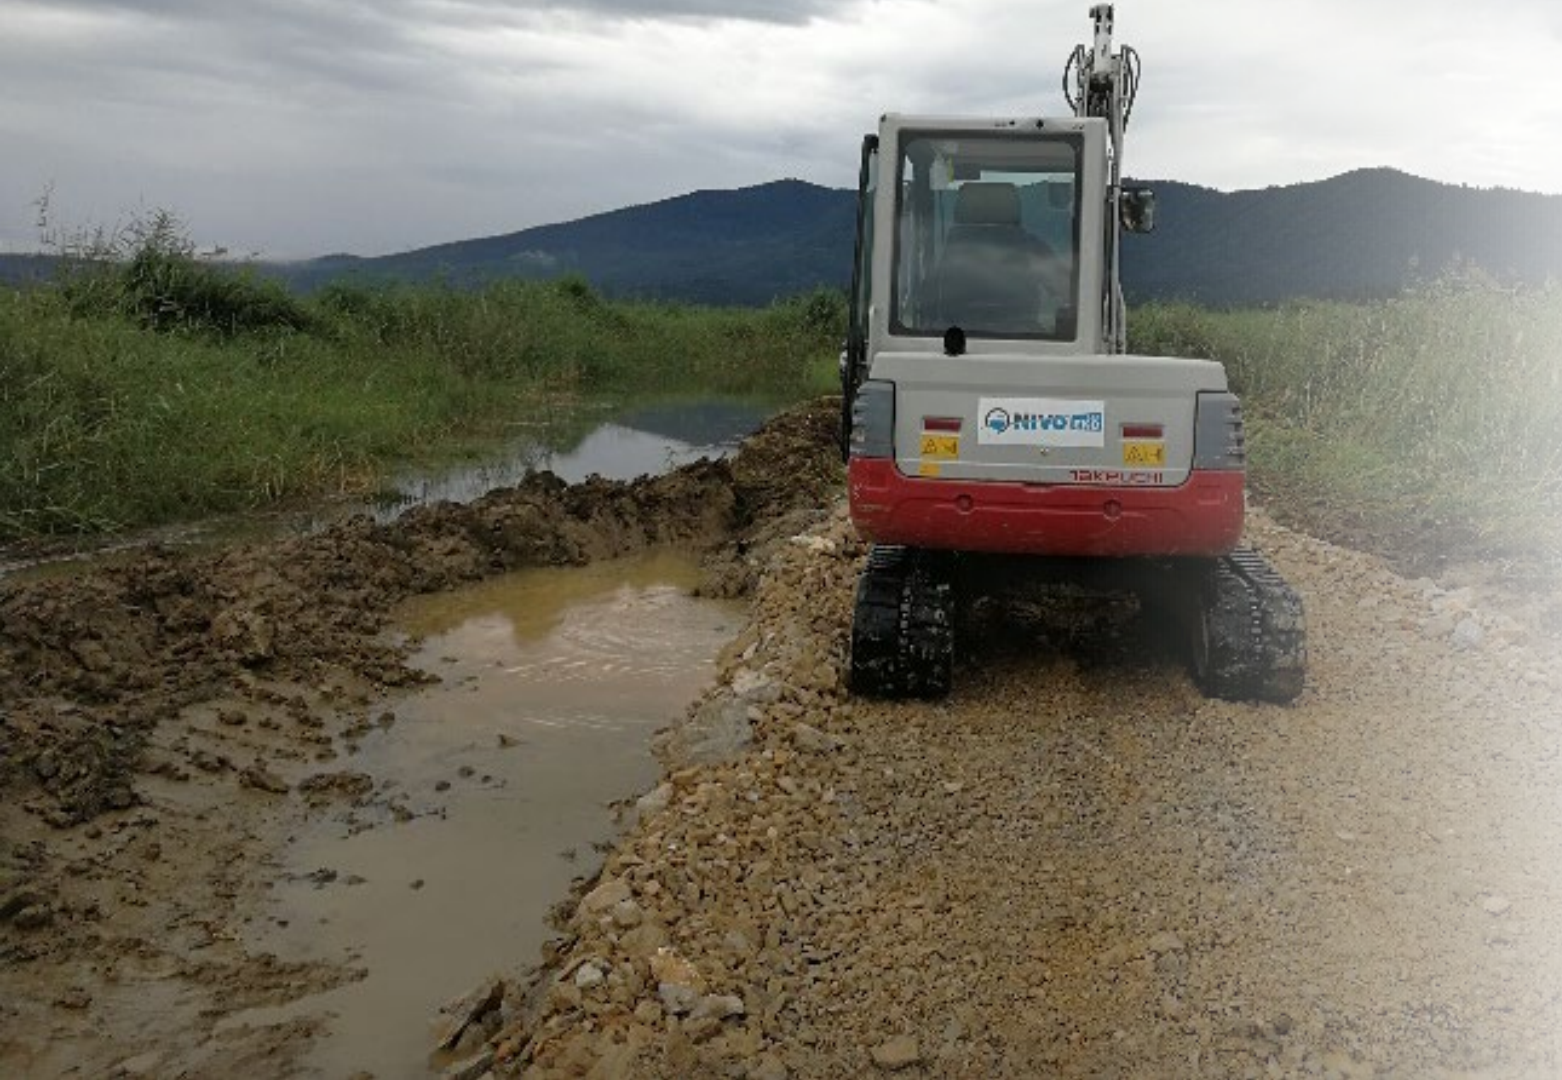
Preparing access road to the restoration area

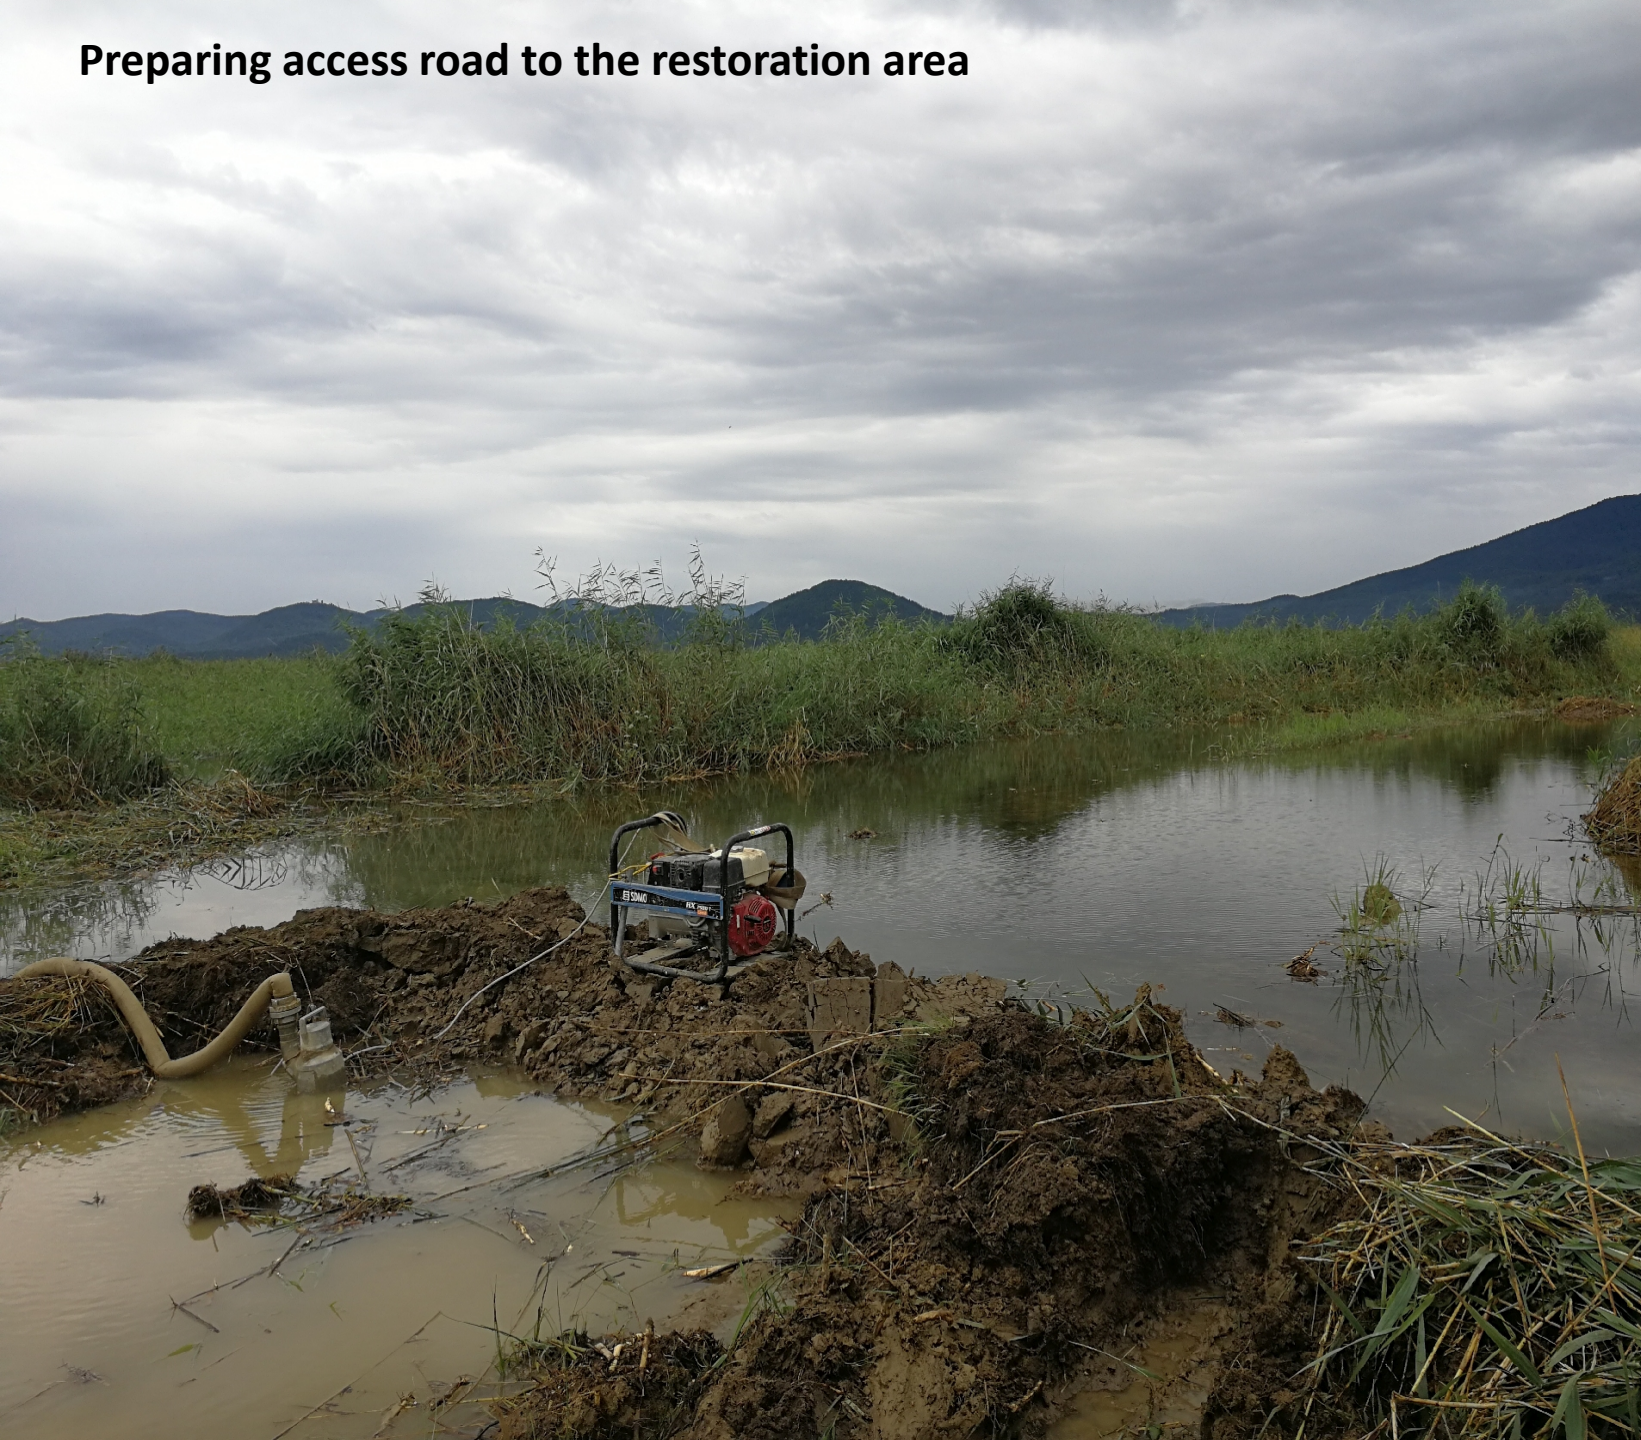
The only access to the watercourse, which was overflowed until 20 Aug 2019, due to high water levels

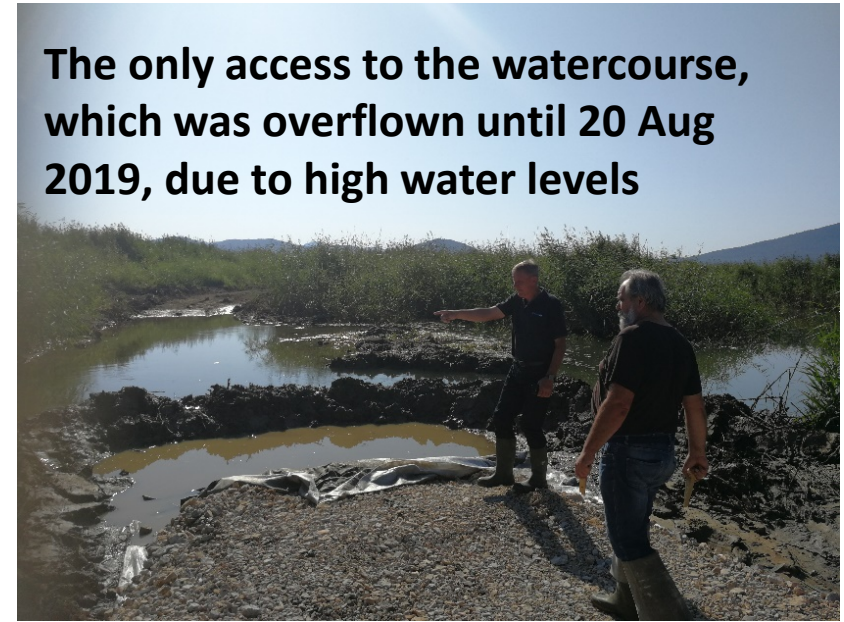
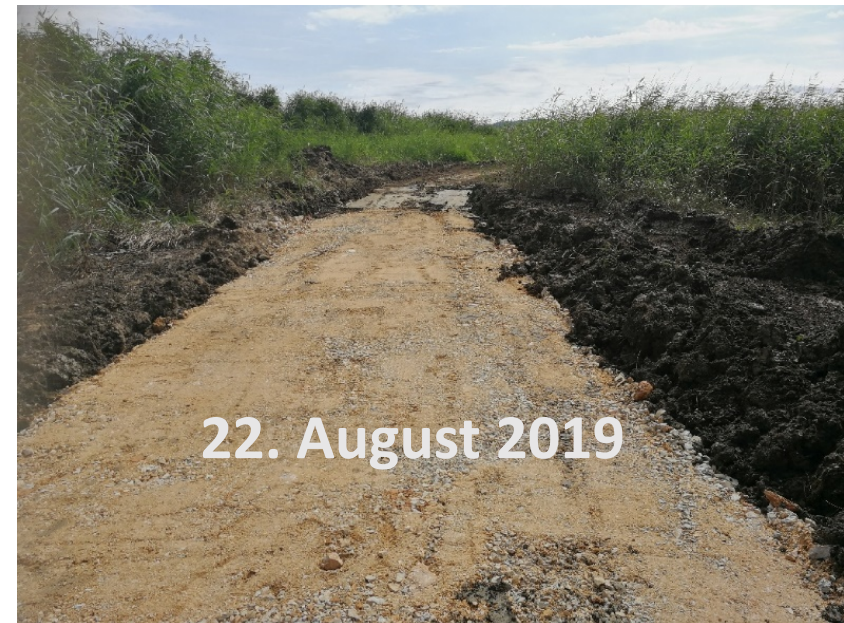
22. August 2019

Excavation of the meander

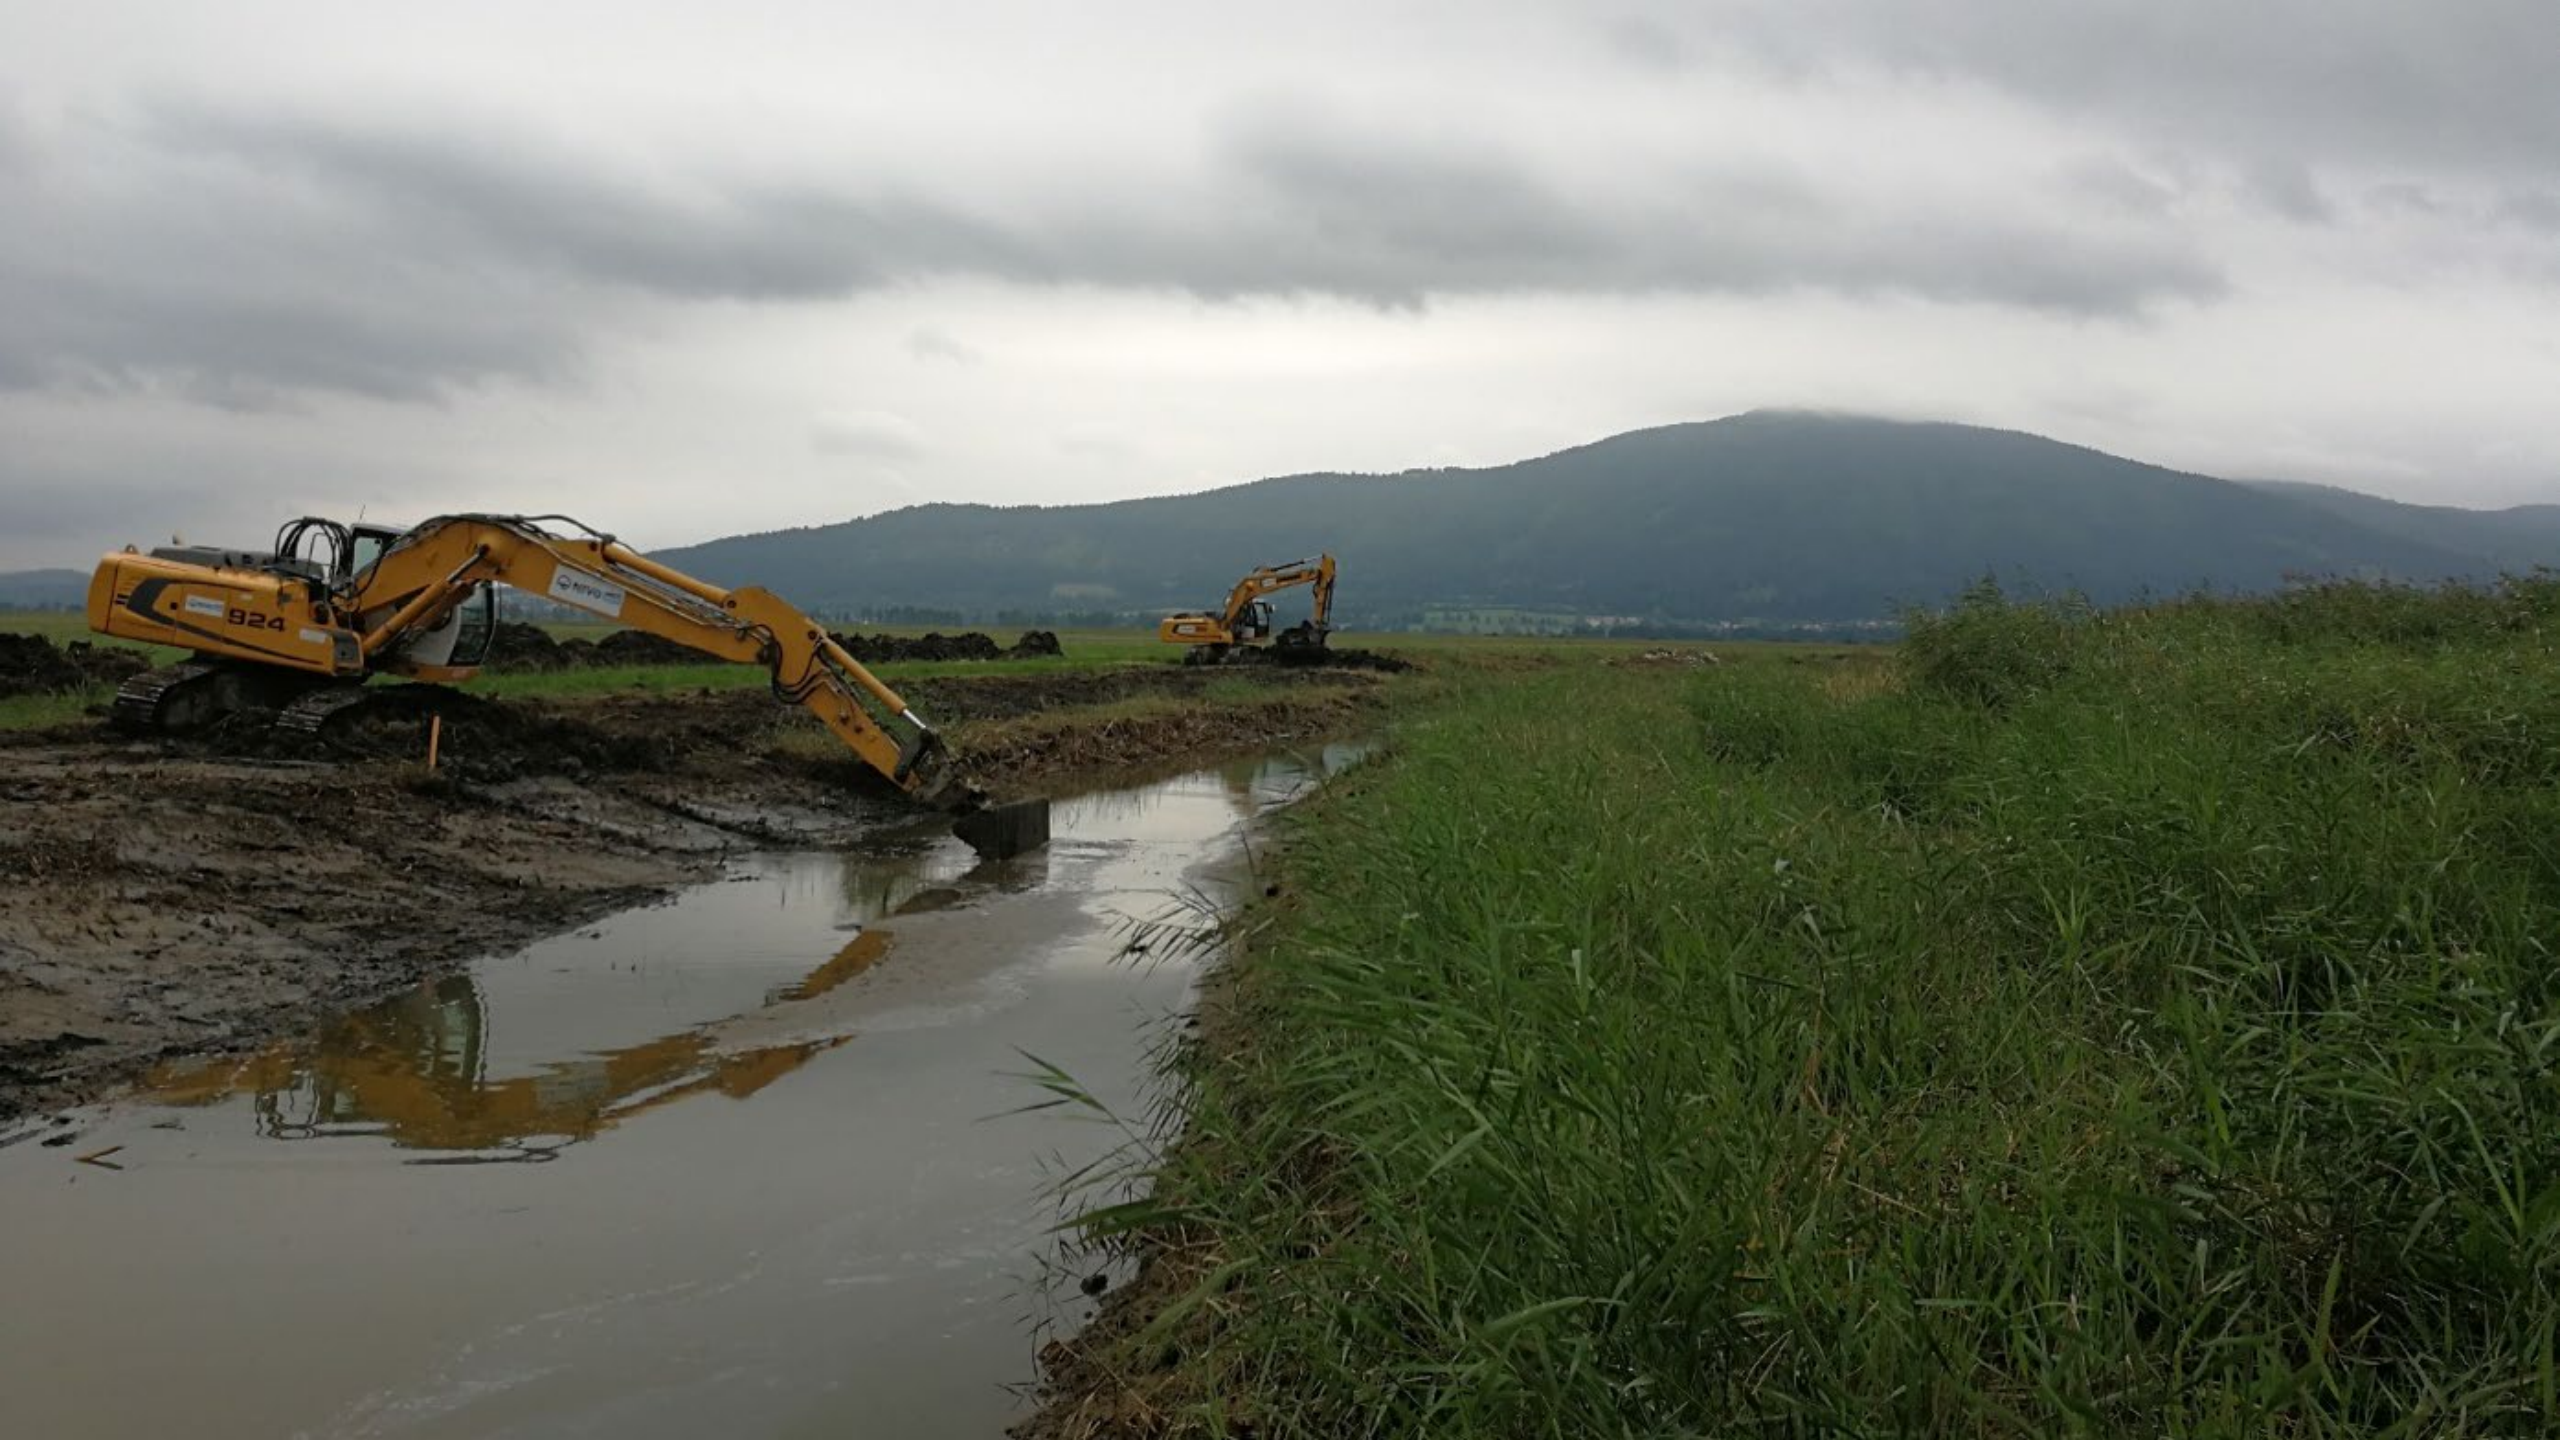
The highest up-stream crossing set-up

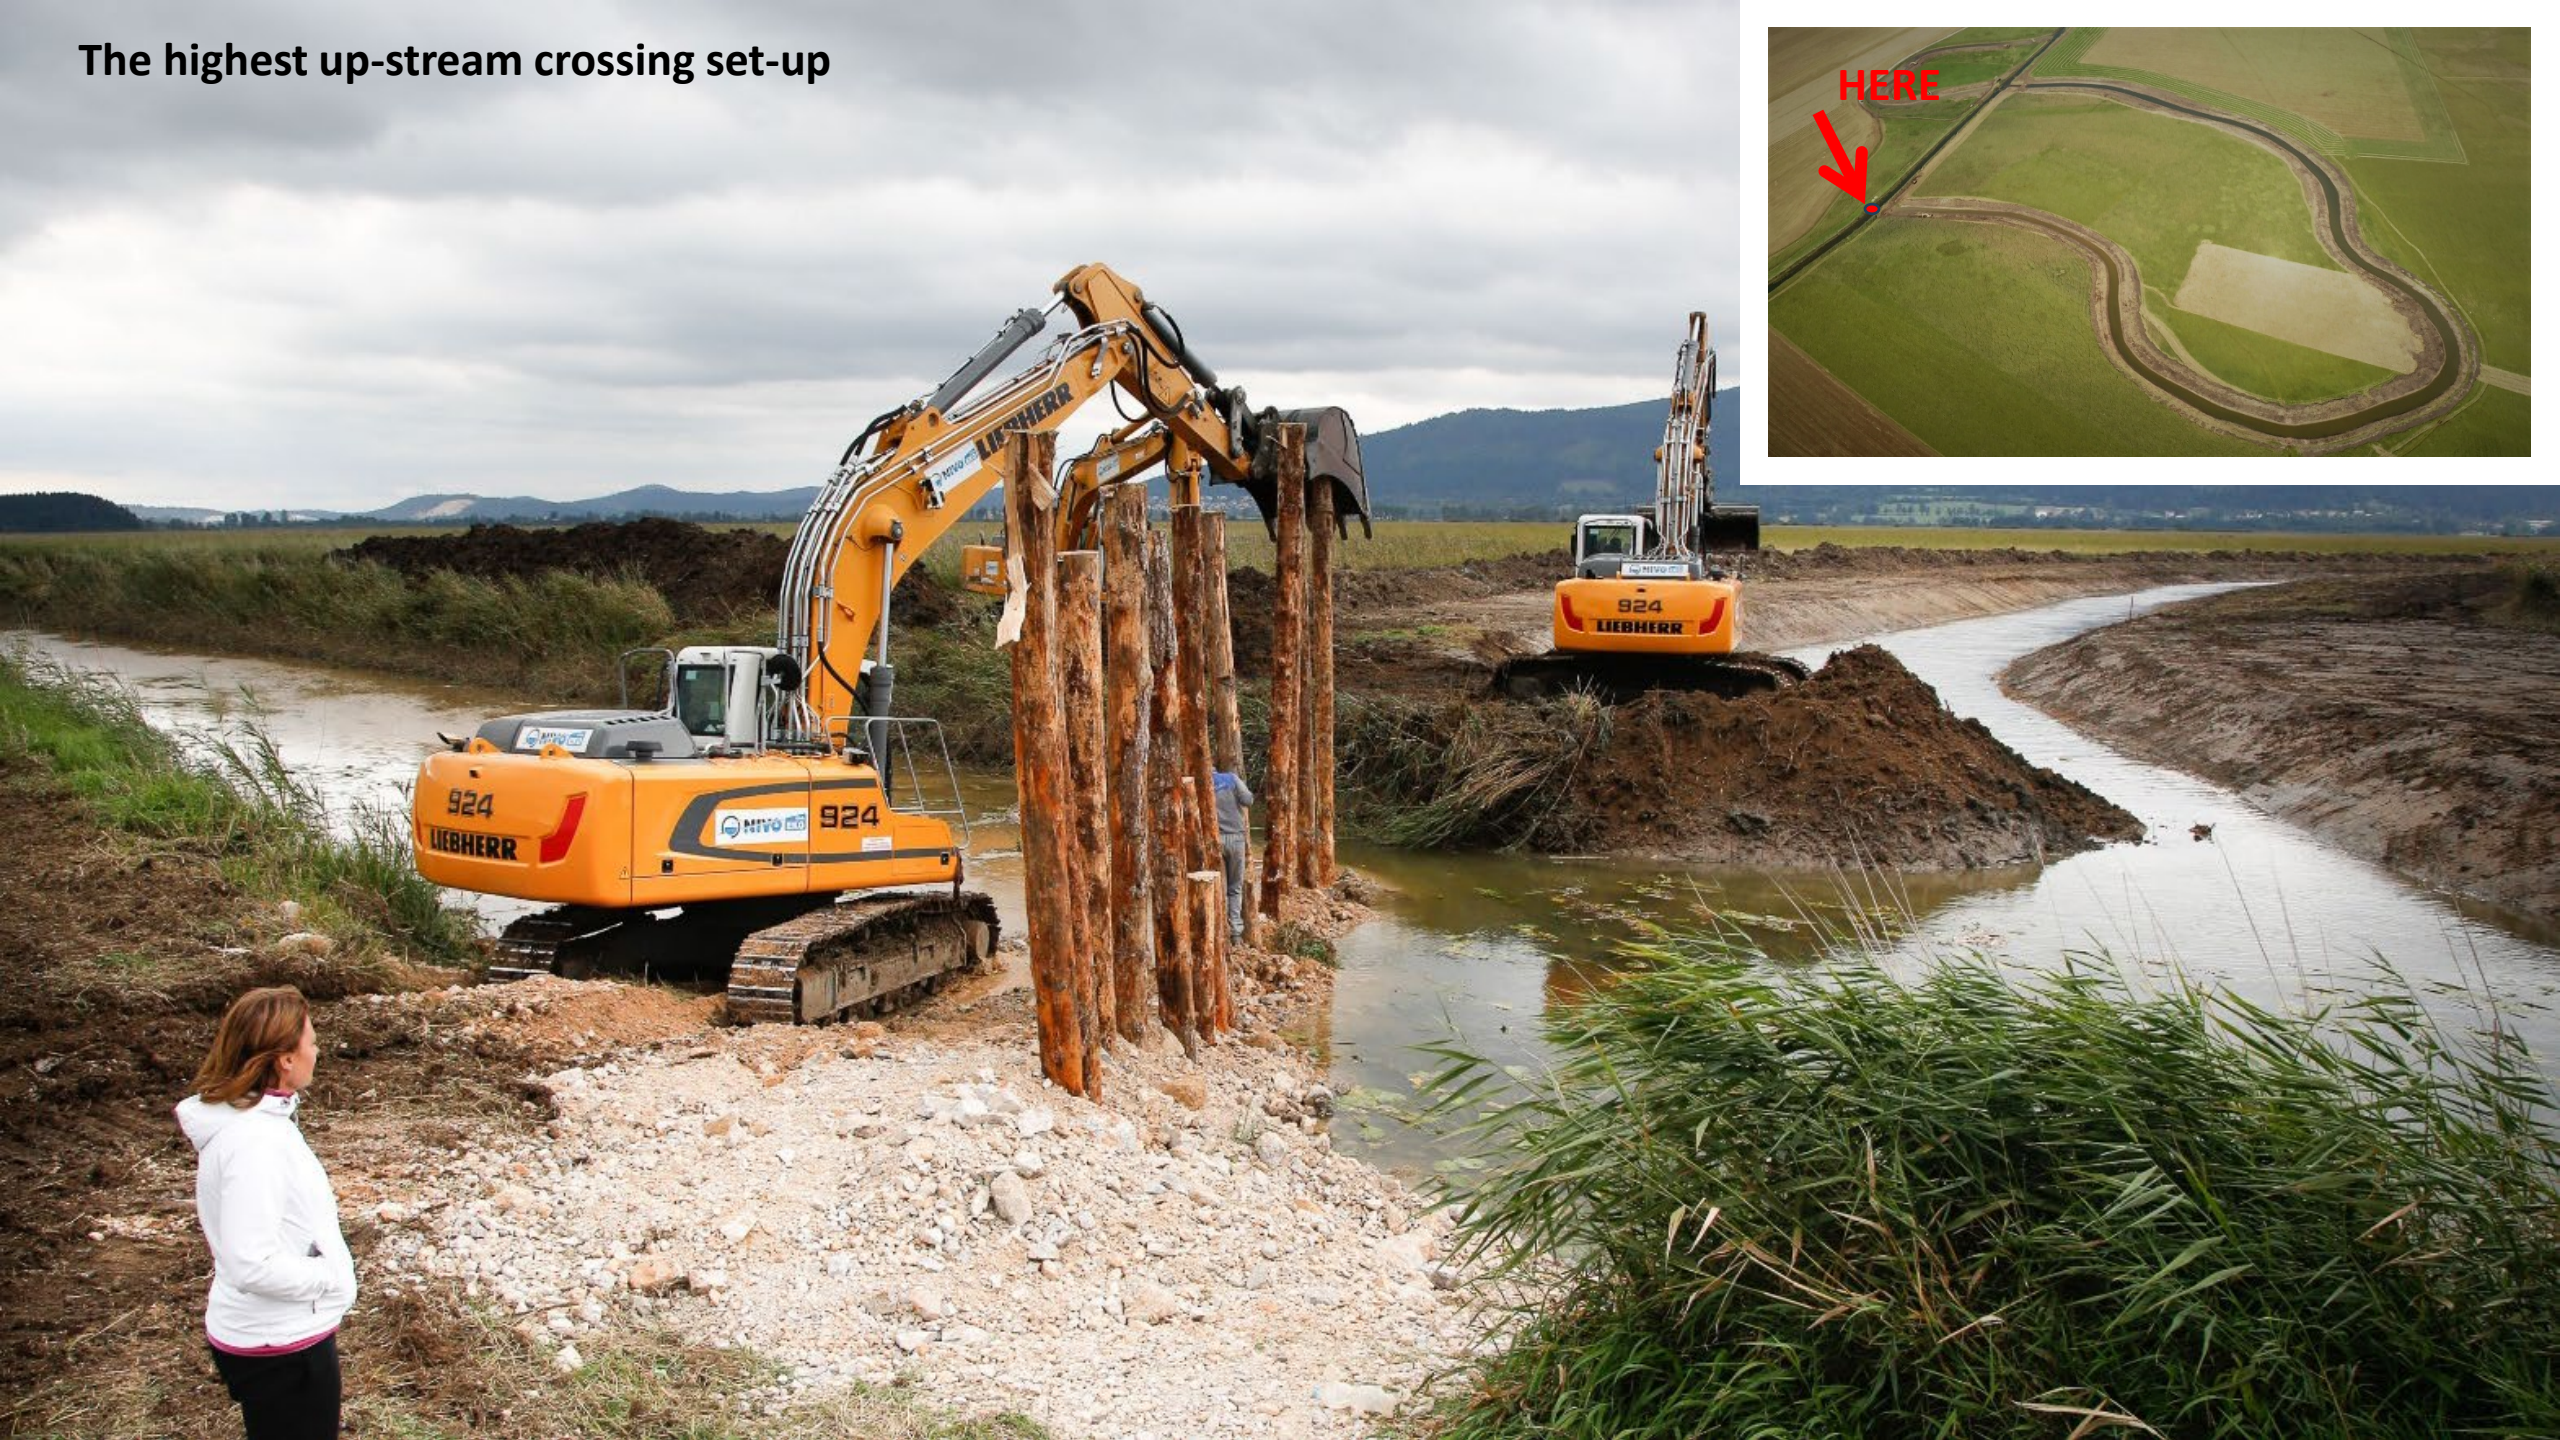
Watercourse redirection into the newly dug out meander

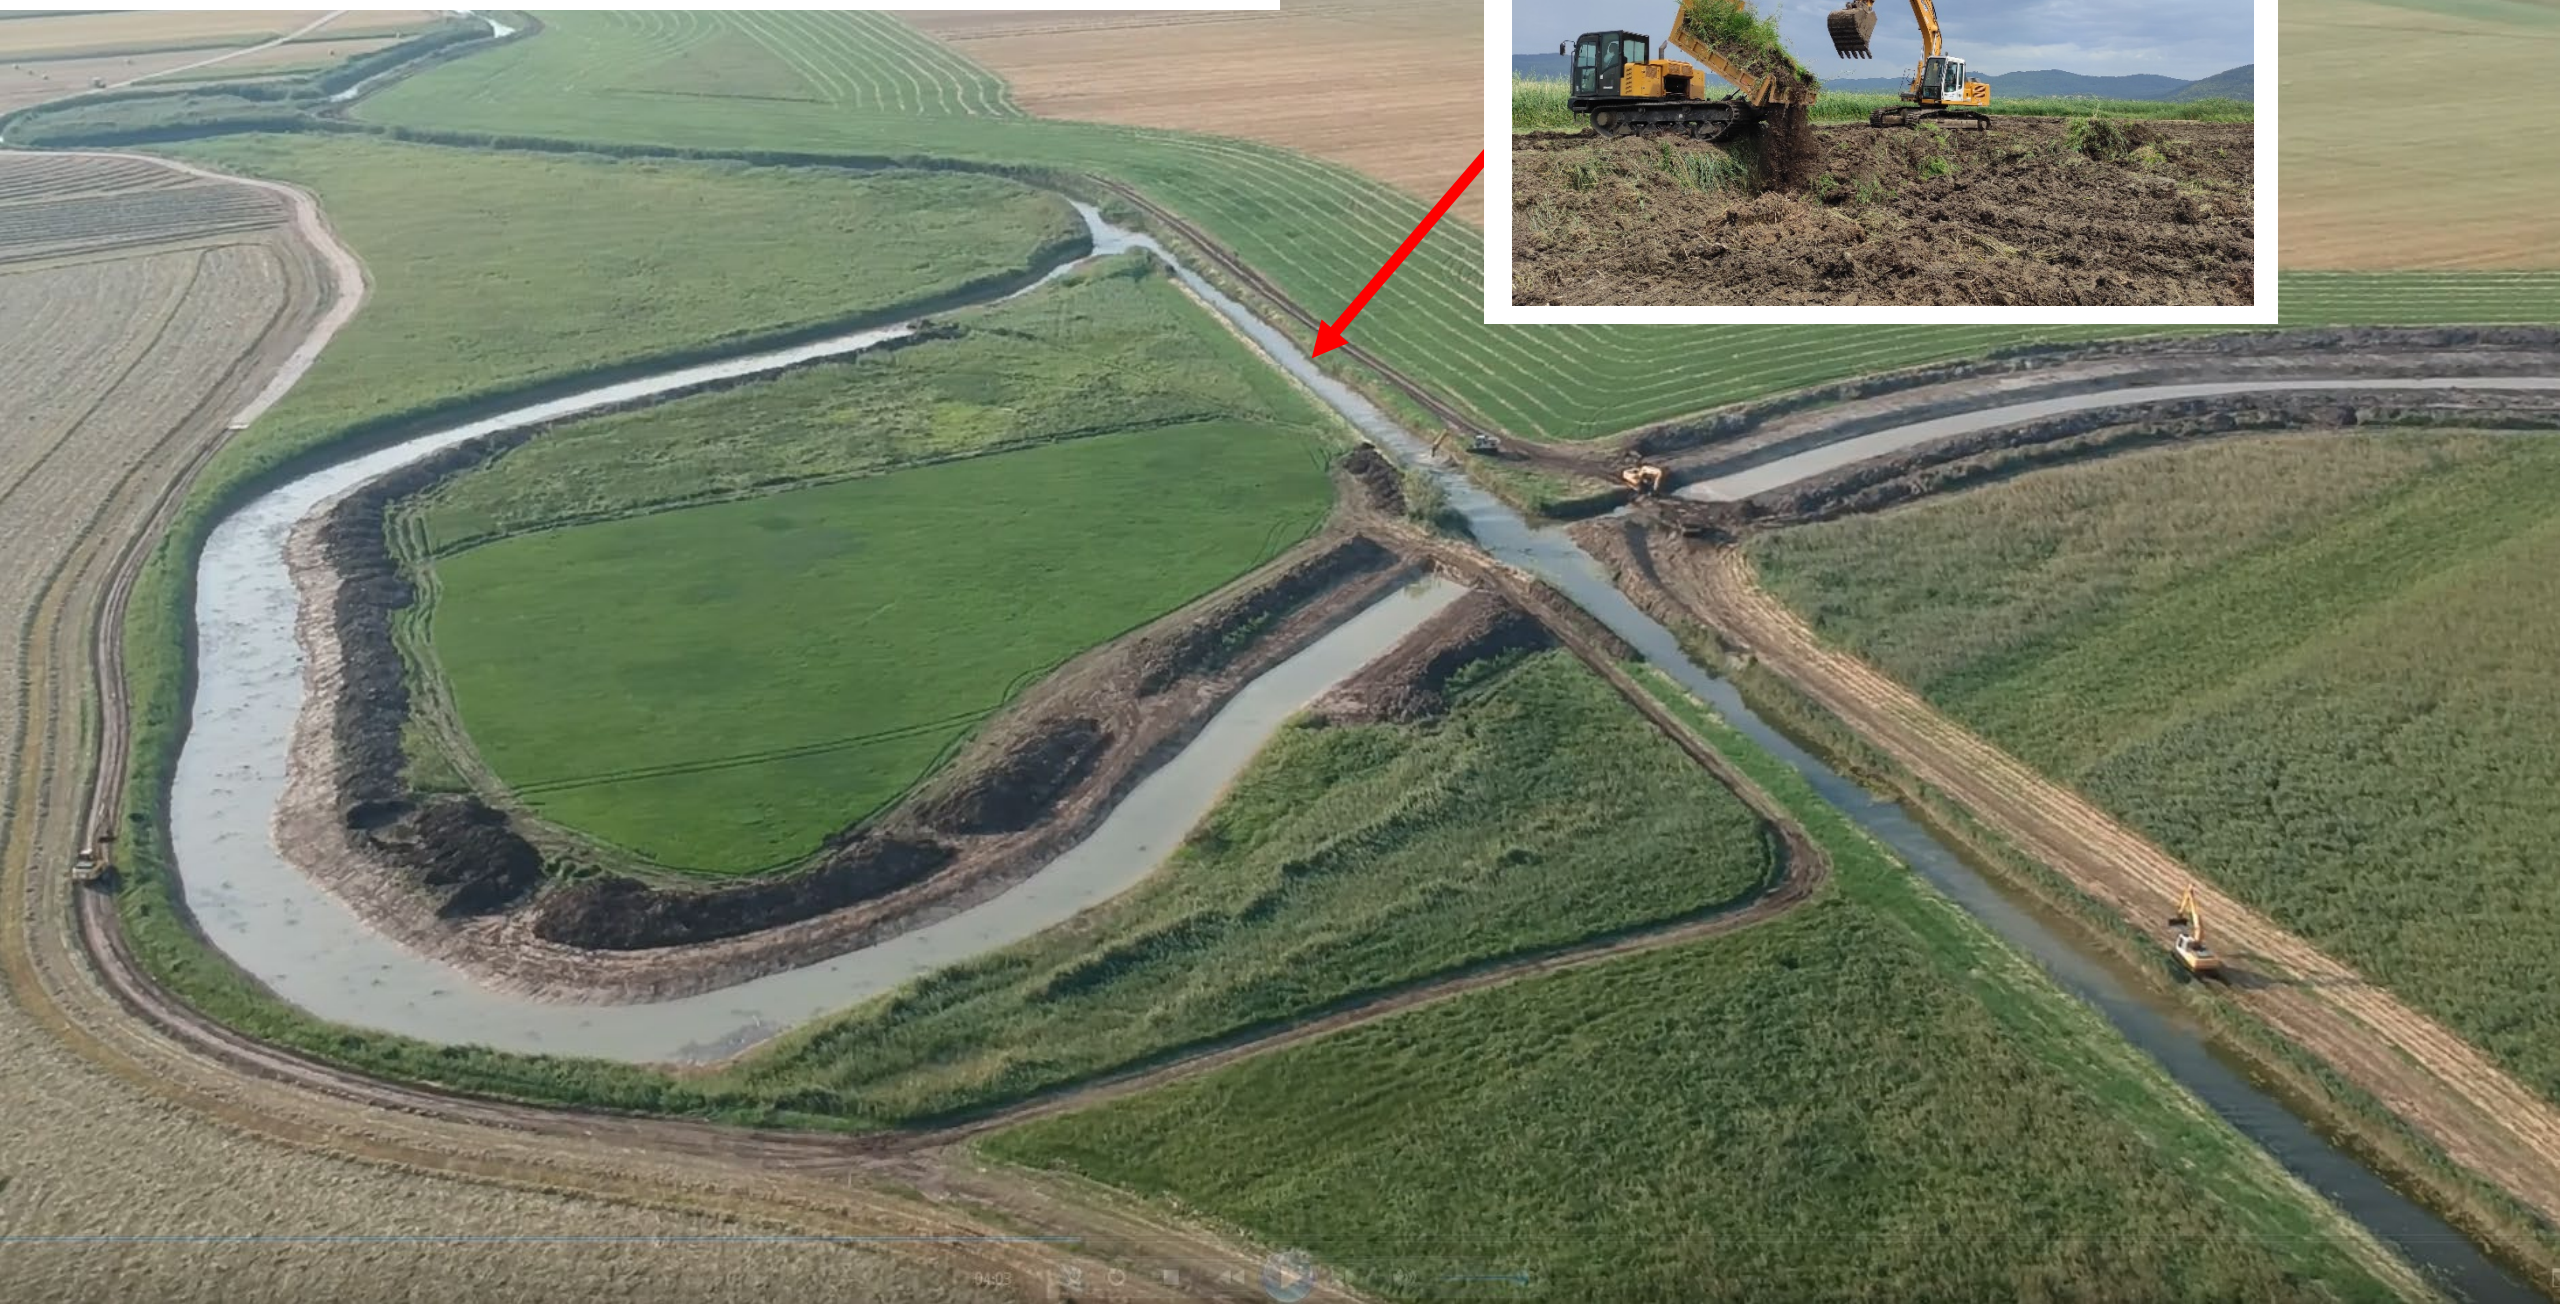
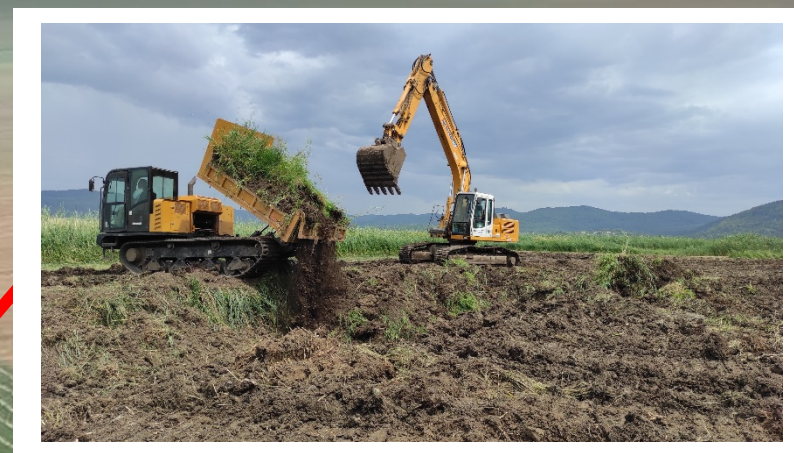
We started to pump out water from the canal.
