WATERCOURSE RESTORATION EFFORTS at the INTERMITTENT CERKNICA LAKE in SLOVENIA

LIFE06 NAT/SLO/000069 – Intermittent Cerknica Lake

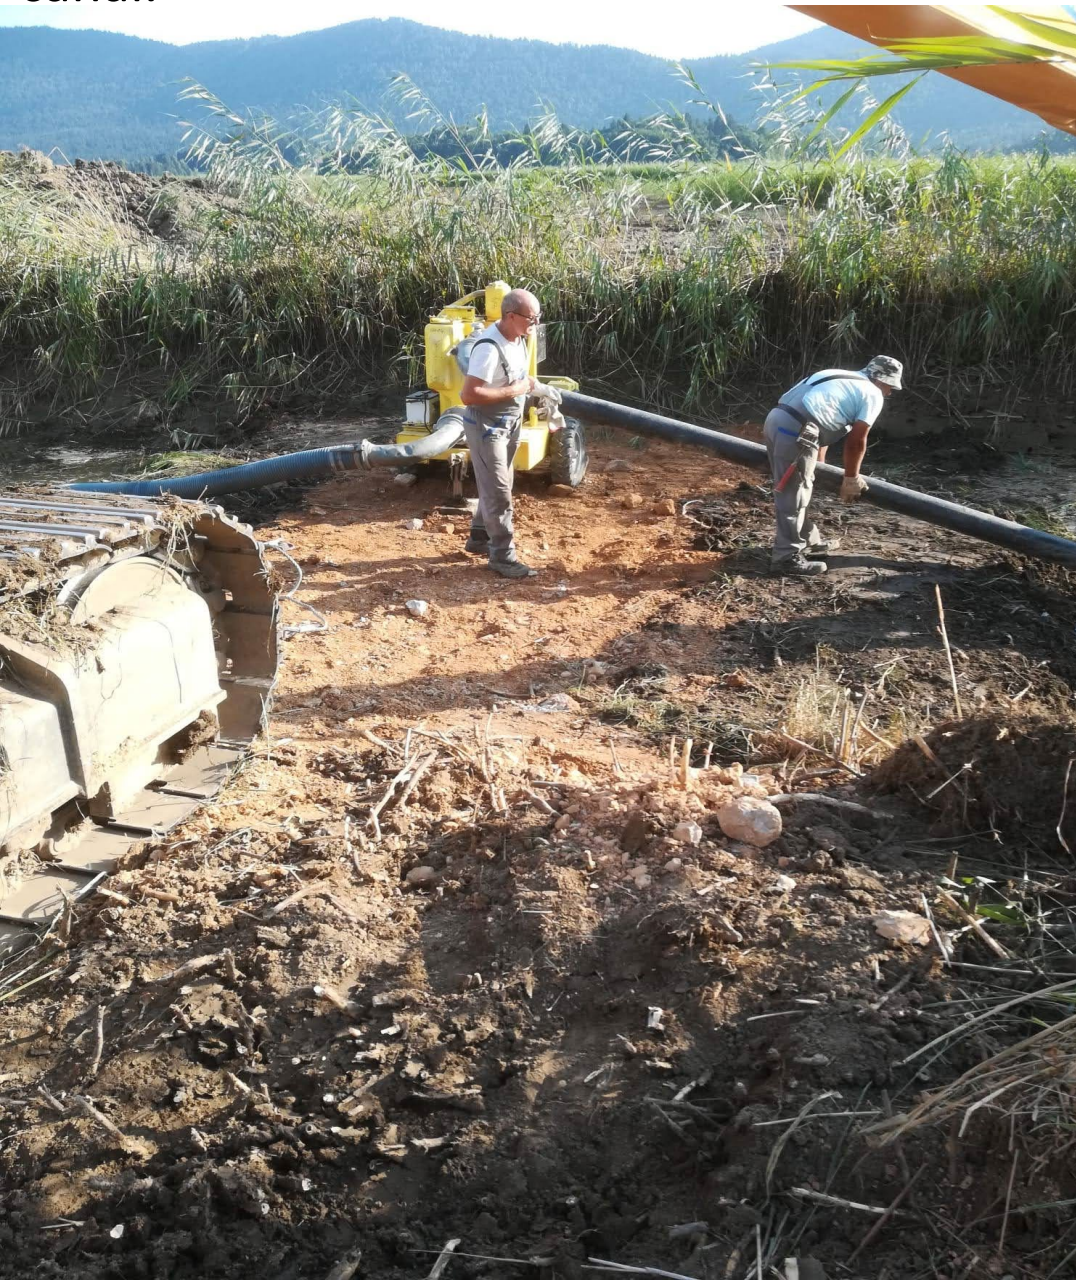
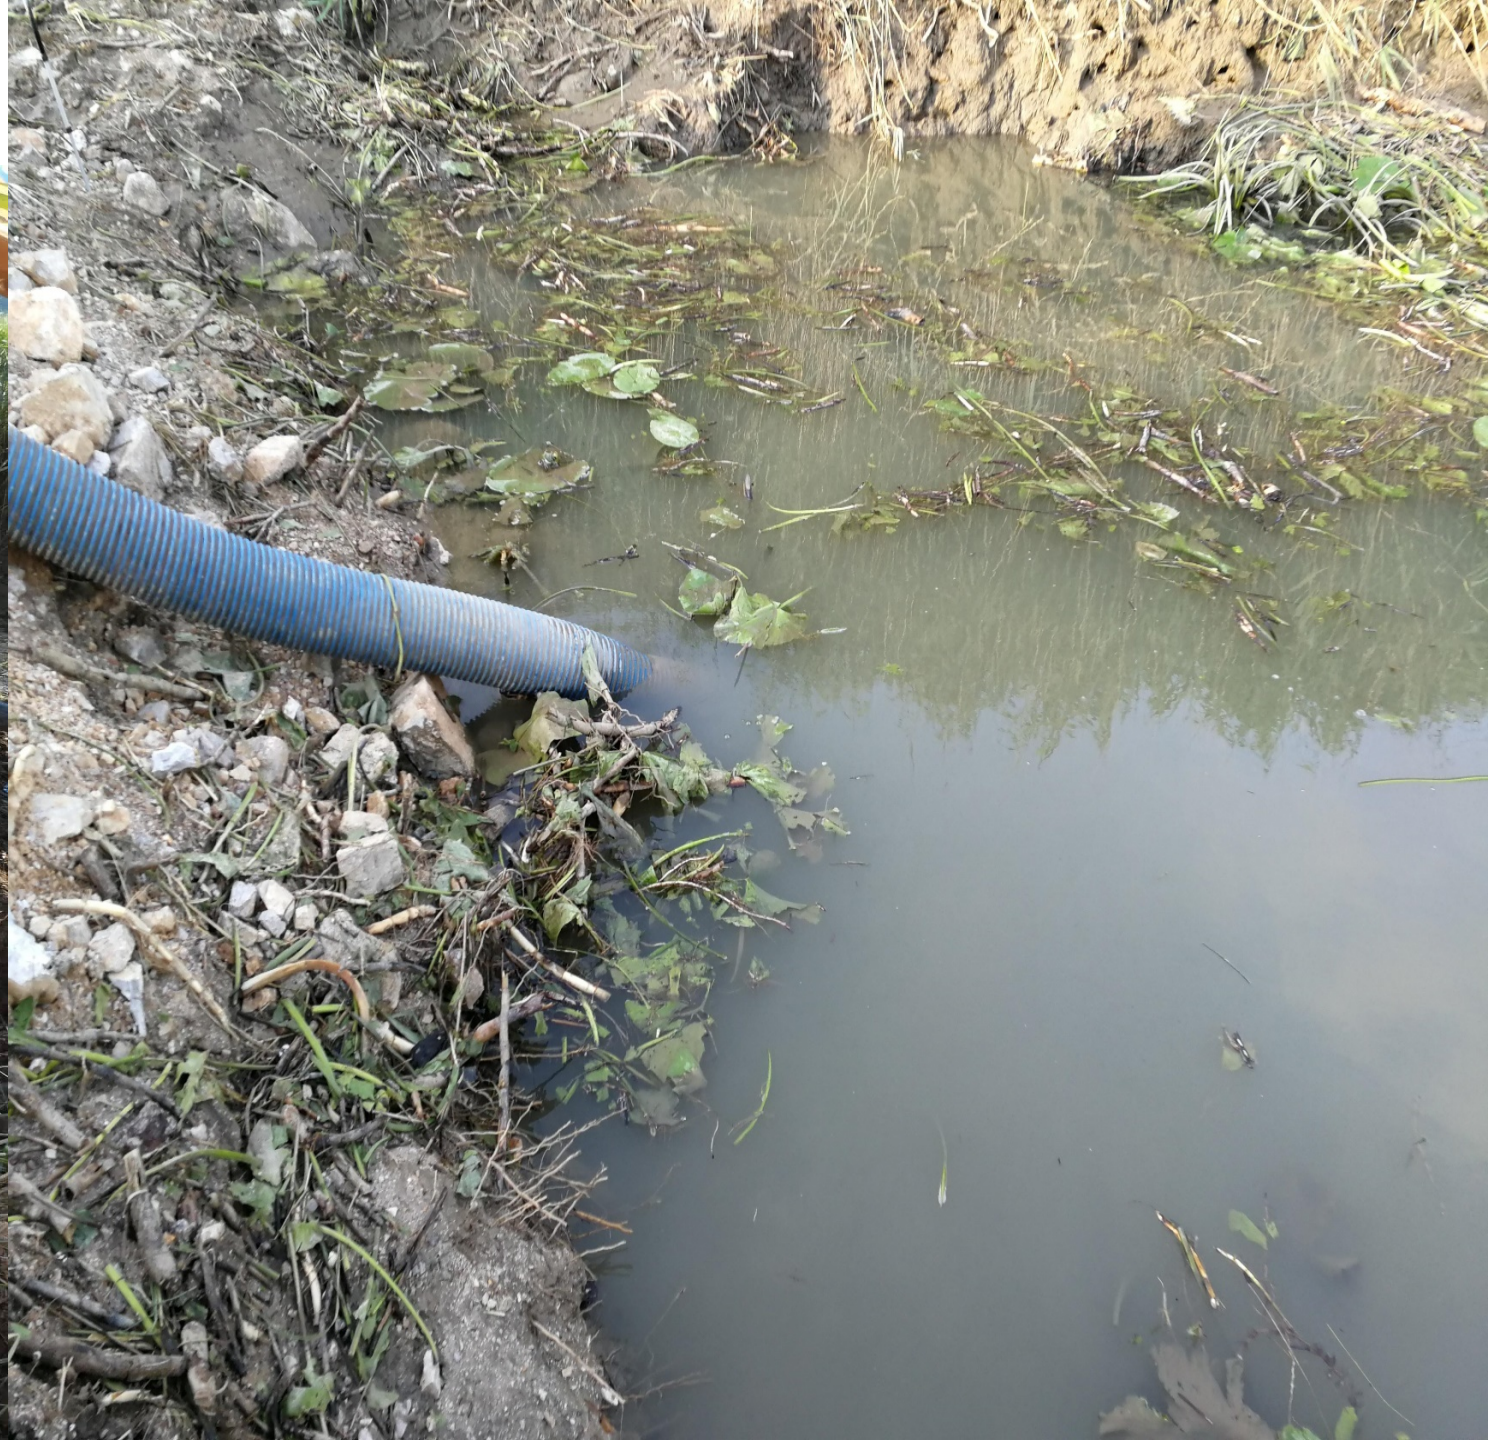
While we pumped out water, we captured fish and crustaceans and moved them to safety

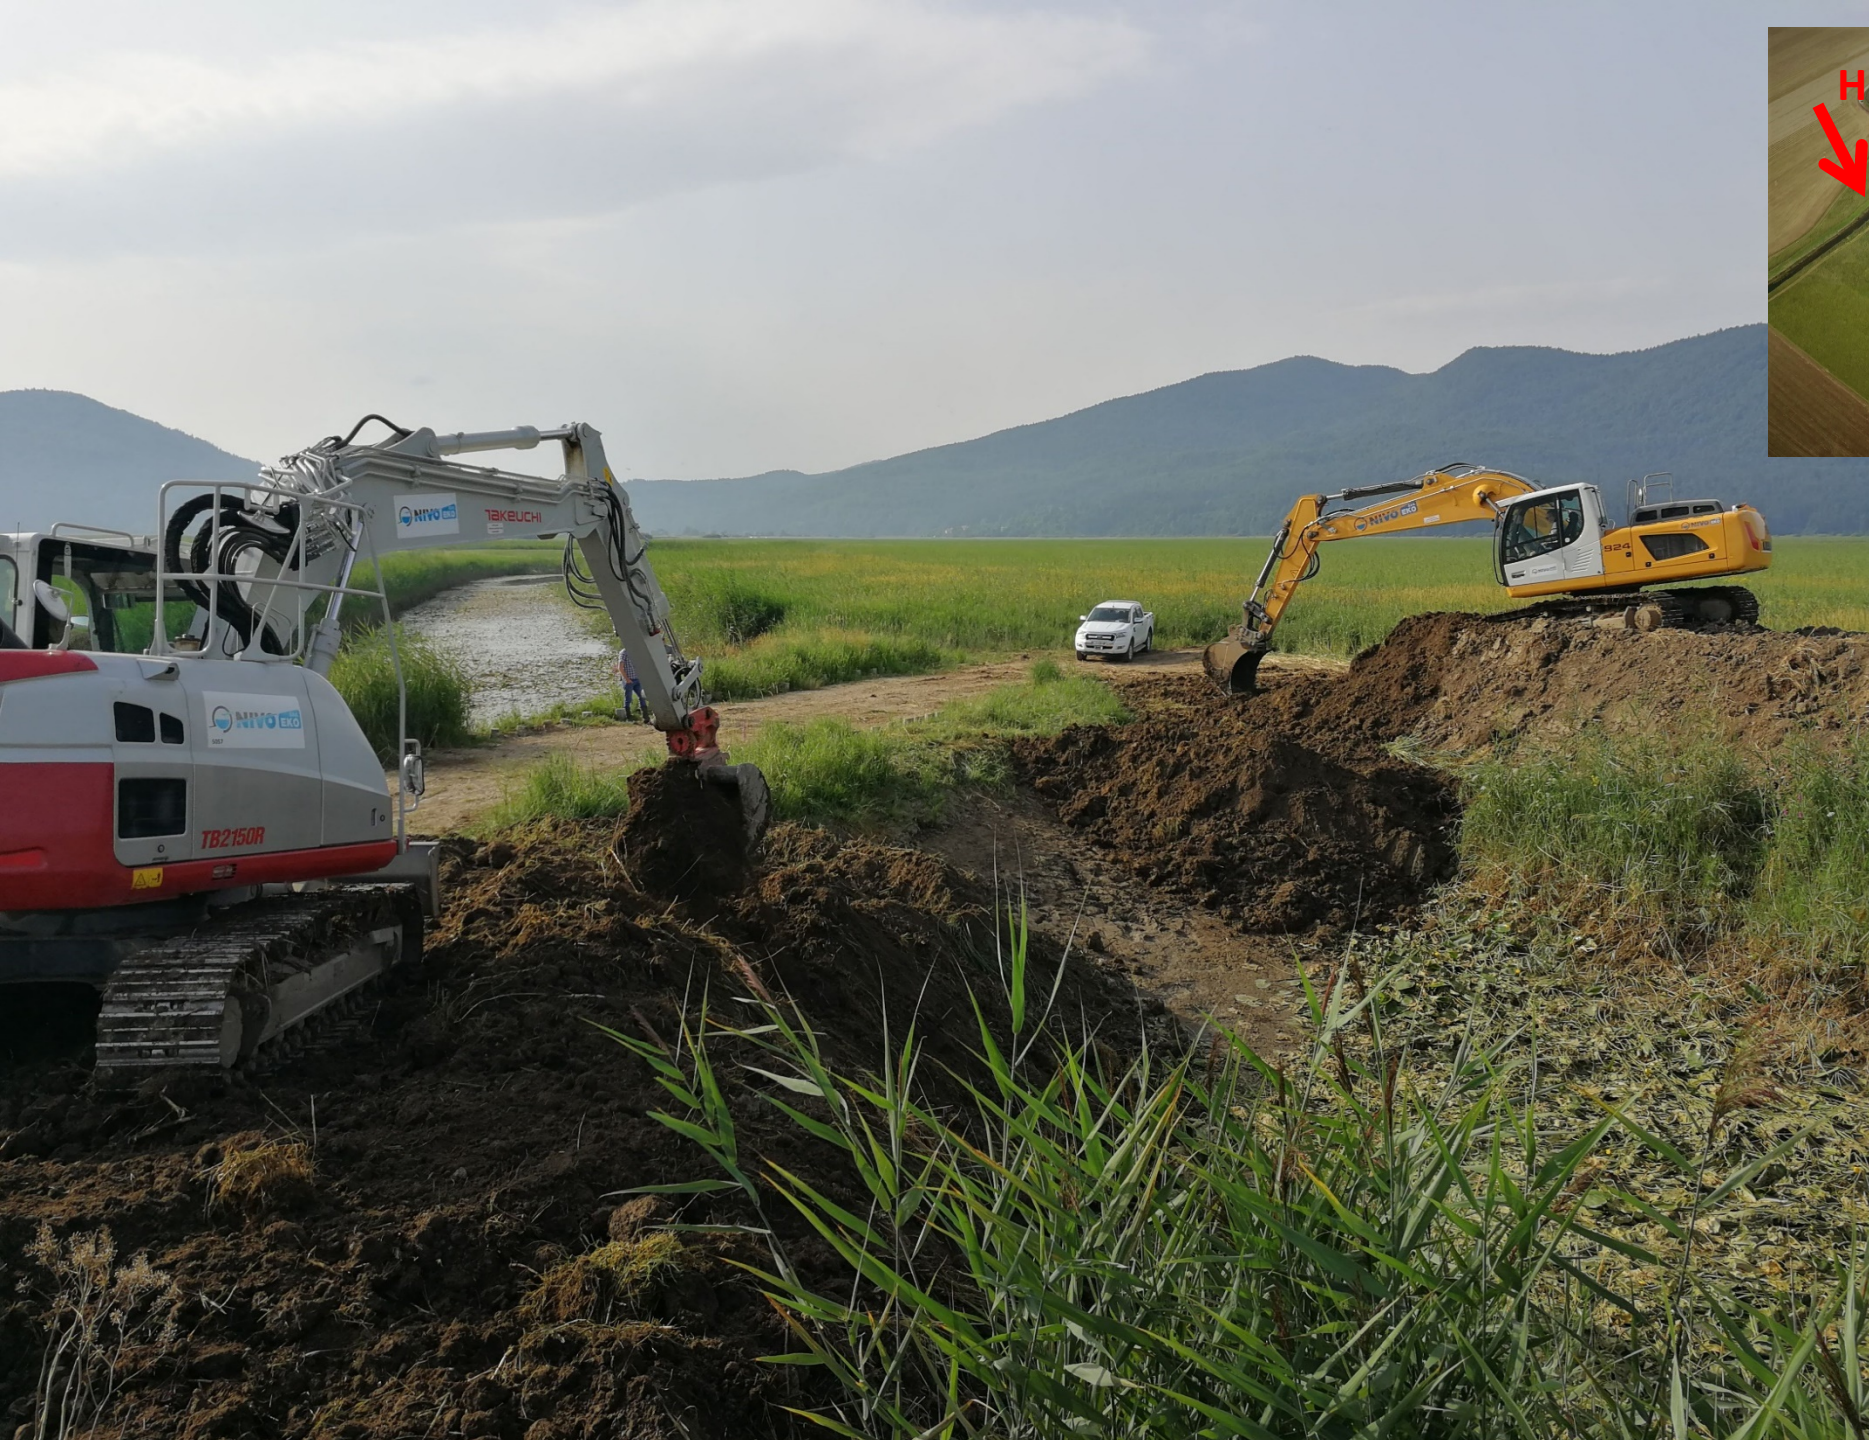
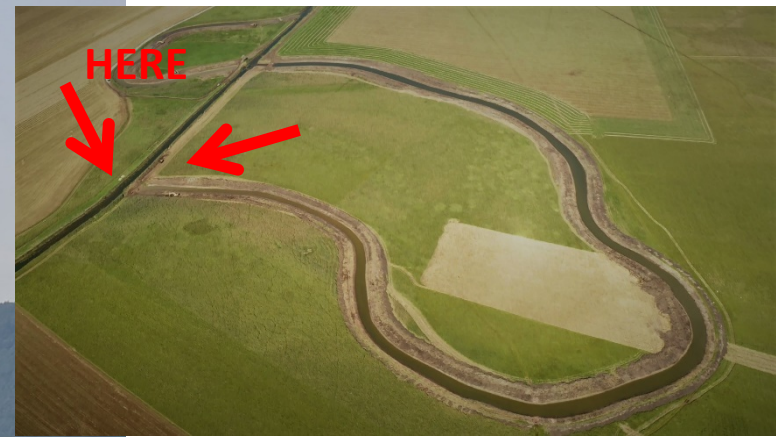
Then, we started putting soil in the dry canal, starting from the upper part and working from both sides of the channel.
